# First-ever VR90s\* operation completed

Clear answers from VR90s Advanced Diagnostic Service enables client to proceed with intervention plan.

CASE STUDY

Client: Major Dutch operator

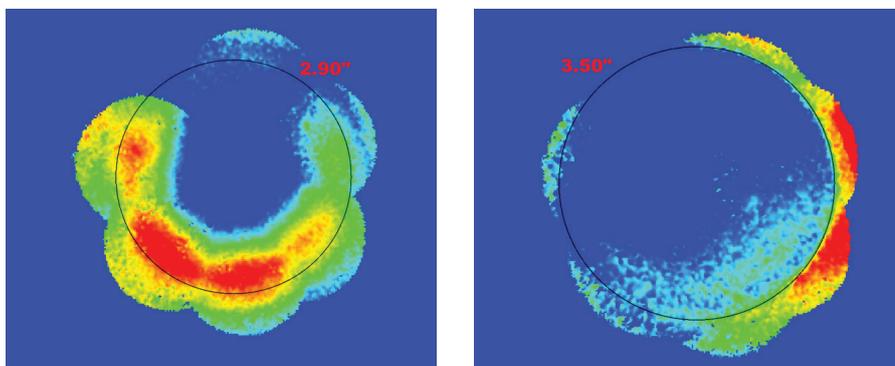
The VR90s tool was run in hole until it tagged an obstruction, which upon imaging, was revealed to be the nipple. The X-ray image acquired (below left) shows the 2.9 in nipple ID, highlighted by the circle annotation. The red and orange region indicates debris on the low side of the well.

The VR90s tool's built-in positioning module was then used to move the VR90s tool 5.5 cm above the nipple. A new X-ray image was acquired (below right), revealing a round profile with a 3.5 in ID. The red and orange region indicate debris on the low side of the well, and the upper portion of the ID appears to be free of fluid, indicating that the ID is not completely filled with debris.

The results demonstrated that the stuck fish was located below the nipple, and while there was sand-like debris in the low side of the well, it did not completely obstruct the nipple profile. It was apparent that the stuck fish could not be retrieved through straightforward fishing methods.
