# VR90<sup>®</sup> service saves customer from costly remediation

Client: Permian Basin operator

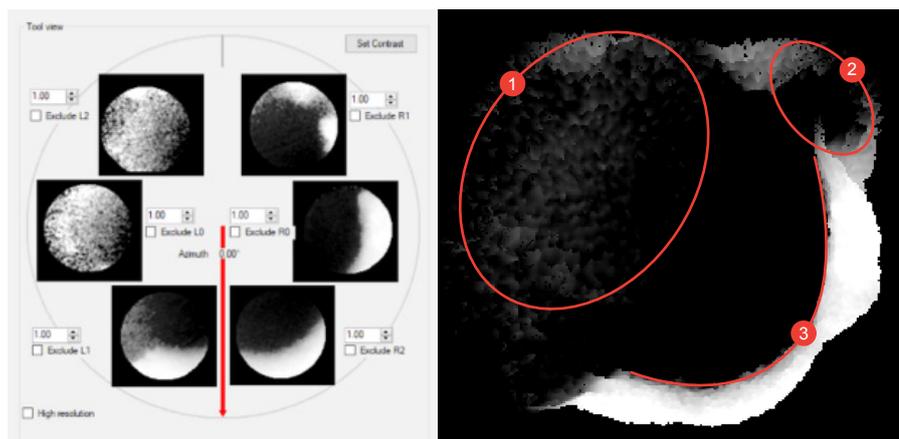
Raw data captured by the VR90 tool.

1. Damaged casing with debris obstructing well
2. Hole in casing
3. Intact casing 3.12" diameter

Real-time images produced at this depth showed a portion of the casing had collapsed and was obstructing the well. The VR90 tool's images also revealed a hole in the casing, which allowed debris to further obstruct the well. A dimensionally-accurate reconstruction of the damaged casing demonstrated that the diameter of the intact casing was about 3".

Thus, less than three hours after the VR90 tool was deployed at the wellsite, the cause of the obstruction was determined to be partially collapsed and damaged casing, with the hole in the casing indicating that the integrity of the casing might be compromised. This diagnosis made it clear to the client that the plan to mill through the obstruction would possibly compromise the integrity of the casing further, and a safer course of action would be to simply plug the well above the obstruction.

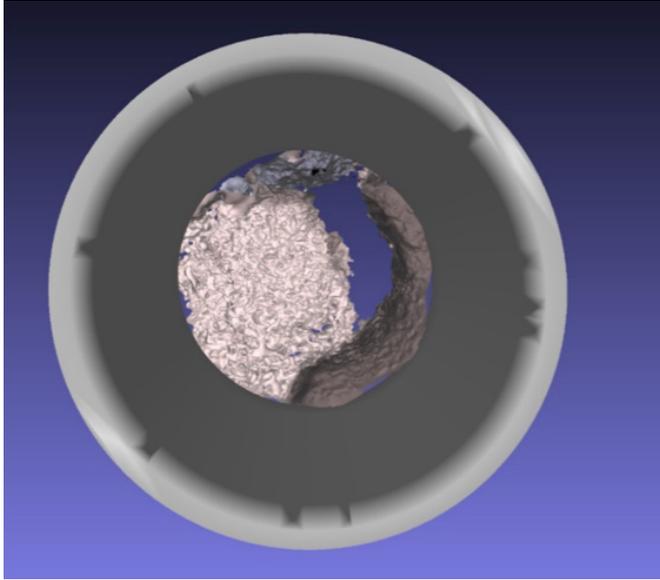
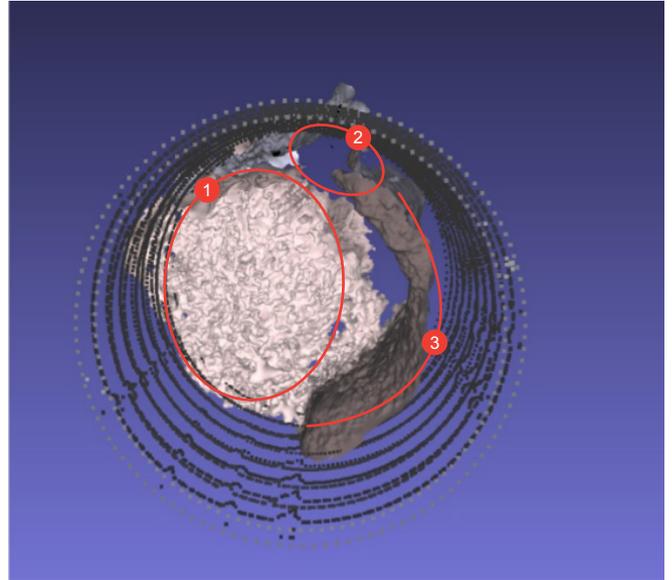
Reconstruction of damaged casing.

1. Damaged casing with debris obstructing well  
 2. Hole in casing 3. Intact casing 3.12" diameter
