# VR90® X-ray technology images top of fish to millimeter accuracy

Operator TAQA Energy B.V. subsequently ran a successful fishing job in their gas-storage well.

Client: TAQA Energy B.V. (Netherlands)

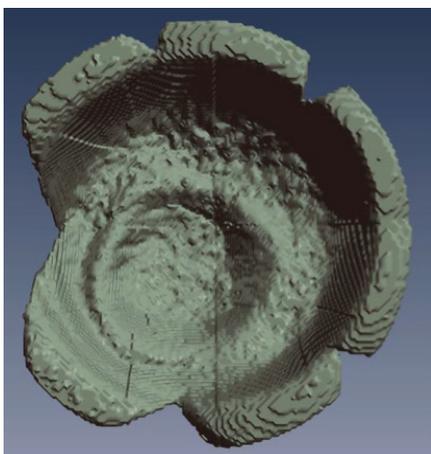
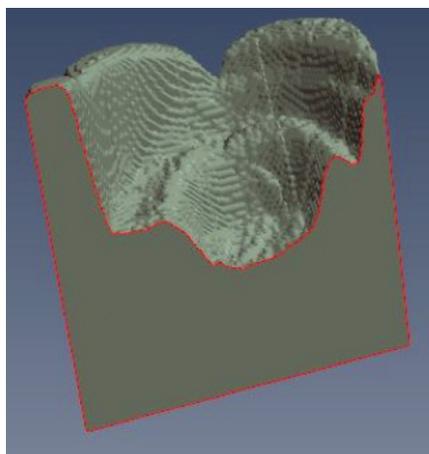
In this case, the VR90 was run in the client's well to tag the bottom-hole assembly, and clear 2D and 3D images of the fish were obtained in minutes. The 3D images below are, left to right, a reconstruction of the top of the fish and a slice through the same reconstruction. The outermost circular object is the coiled-tubing disconnect, while the eccentric circular object positioned inside and below the disconnect is suspected to be debris that has accumulated inside the downhole assembly.

The VR90 images and the accuracy of the measurements assured the client that the fish was indeed the expected coiled-tubing disconnect and enabled a fishing operation to proceed without risk. A fishing operation was later successful in a single run, and the bottom-hole assembly was retrieved, confirming the accuracy of the X-ray image.

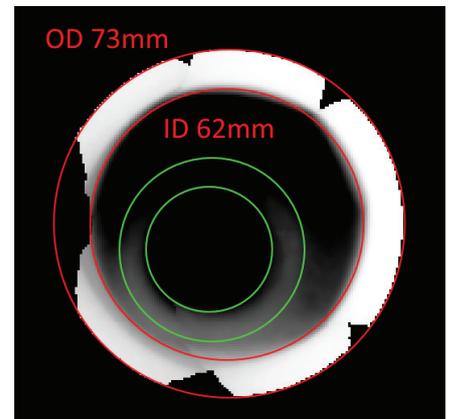
Real-time analysis of the 2D image (right) showed the outer and inner diameter of the fish to be  $73 \pm 1$  mm and  $62 \pm 1$  mm respectively (red circles). As these measurements matched exactly the coiled-tubing disconnect, the VR90 survey confirmed that the fish was indeed the coiled-tubing disconnect and that the disconnect was intact. (Missing parts of the images are outside the field of view of the instrument.) The green circles outline the debris.
