VR90® X-ray diagnosis illuminates problem with stuck tubing

Downhole X-ray imaging provides dimensions and location of tubing top to guide fishing.

CASE STUDY

Client: Large independent operator, US land

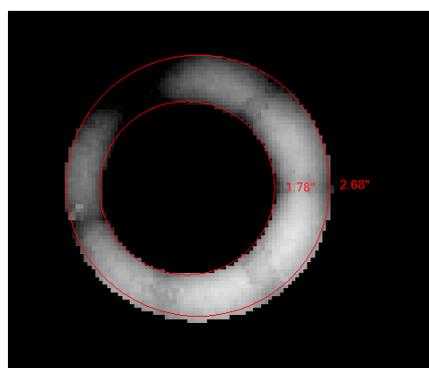
The first image on the right shows measurements of inner and outer diameters of the tubing derived from VR90 X-ray images. The outer diameter of the tubing has been reduced from the original 2.875 in to 2.68 in as a result of the concave milling. The inner diameter of 1.78 in is also smaller than before milling.

Top of tubing with measurements

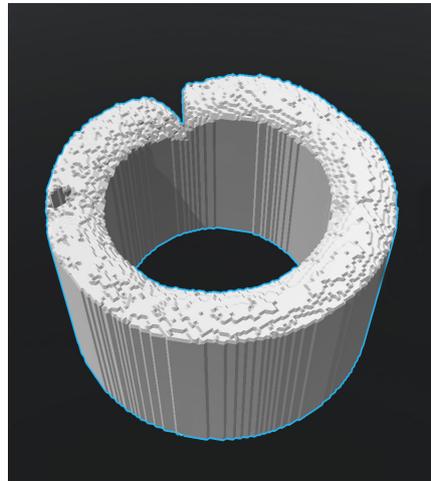
The 3D reconstruction shown in the first image on the right, shows the damaged and uneven condition of the fish. Additionally, on the left side, debris can be seen that was consistent with the size of returns found when pulling out of hole.

3D reconstruction of tubing

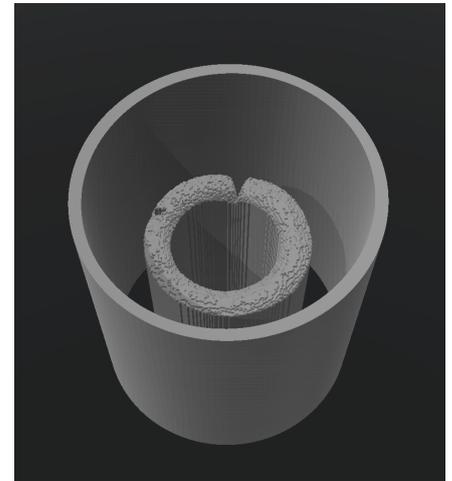
From the illustration shown far right, the tubing was shown to be fairly centered in the casing, with no discernable angle of orientation, nor any pinching or collapsing of the surrounding casing that would have prevented it from being latched with an overshot.

Tubing in casing
