VR90® service shows clear solution to stuck tubing

Assessment of top of a twisted-off tubing section facilitates efficient fishing recovery.

CASE STUDY

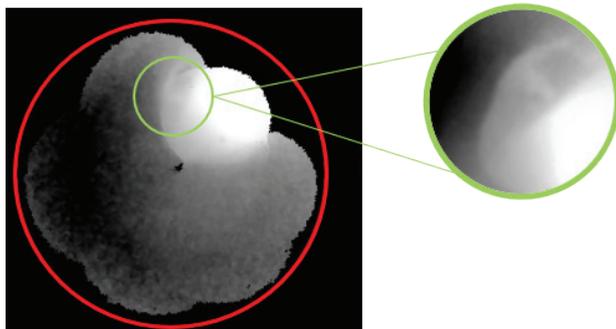
Visuray ran the VR90 downhole X-ray diagnostic service to examine the obstruction, which was revealed to be the twisted-off tubing. The real-time results also provided key information about the size, position, and condition of the tubing top.

The image below is a 2D X-ray image taken by the VR90 tool, with a zoomed-in inset of the ragged edge detail on the tubing top. On the next page, the image on the left is a false-color representation of the tubing top. The colors have been used to highlight the shape of the tubing; red areas correspond to parts of the tubing sticking up, while green to blue areas correspond to parts of the tubing deeper in the well. The client was able to see immediately that the tubing top lay towards the high side of the well. It also showed that the tubing top was thoroughly mangled, and crucially, that a section of the tubing had folded over.

Based upon this diagnosis, Visuray engineers recommended a fishing strategy to retrieve the tubing, including specifying a particular type of grapple to grab the fish. The operator and fishing company followed Visuray’s suggestion and successfully fished the tubing the next day. The image below on the right shows a photograph of the retrieved tubing. The mangled, crushed, and folded top of the tubing are a match with the VR90 tool results.
