EVALUATIVE CASE STUDY

Trouble Milling a Frac Plug

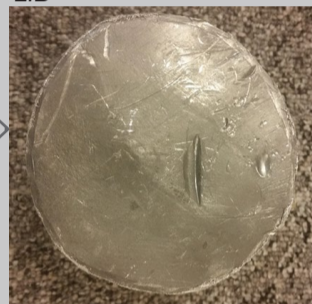
LIB

A lead impression block is run; results show that something may be on top of the plug.
A junk basket recovers nothing.
An optical camera would require a cleanup.

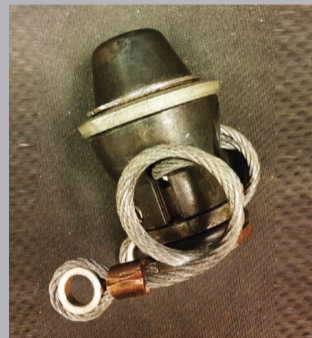
Actual

Fish is quickly identified as an open-hole coring bullet.

A fishing solution is quickly found, and the fish retrieved with onsite slickline.

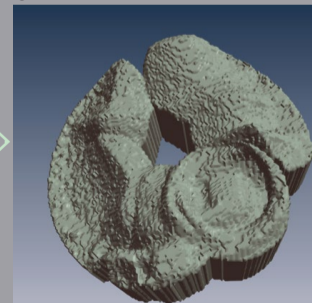
3D

The reason for the milling issue is identified.
