X-PLORING PERFORMANCE PROBLEMS

Radu Achihai, Visuray, Norway, explores how downhole X-ray tools could change the standard intervention approach.

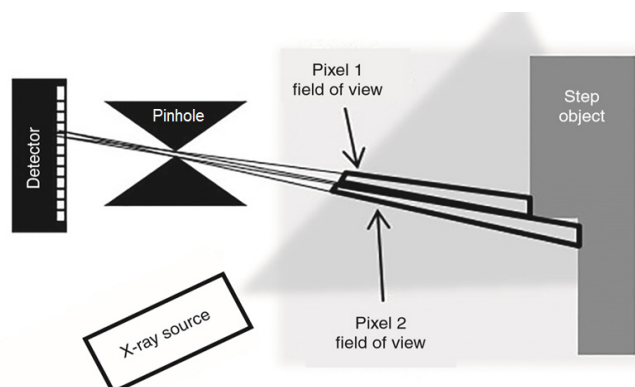
Figure 1. Topographical reconstruction model comparison for two pixels of the X-ray detector.

is present, a greater number of scattered X-rays are registered by the detectors. Thus, as demonstrated in Figure 1, a detector pixel that views a part of an object farther away from the detector will register more X-rays than a pixel that views a part of an object closer to the detector. This creates contrast in the images and can be used to reconstruct the surface topography of the object in 3D.

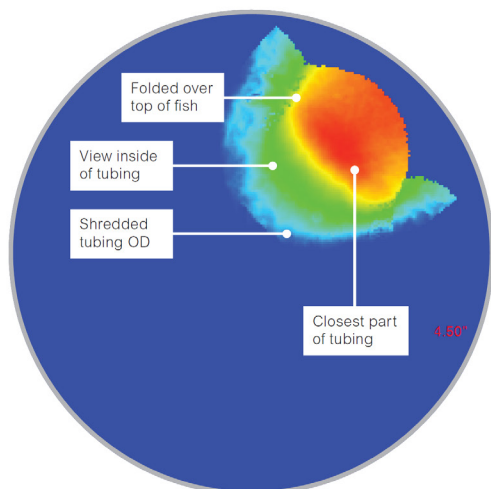
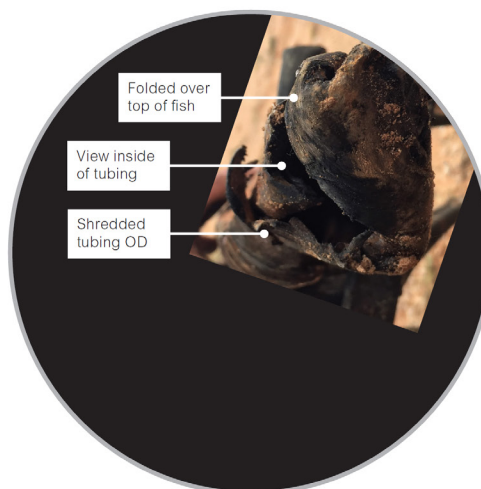
Figure 2. The image on the left is a false-colour representation of the tubing top. The colours are used to highlight the shape of the tubing; red areas correspond to parts of the tubing sticking up, while green to blue areas correspond to parts of the tubing deeper in the well. On the right is a photograph of the mangled, crushed, and folded top of the tubing, taken after it was pulled. This is consistent with the VR90 service's scan results.

the dirty, oily well fluids without any costly and time-consuming circulation of the well. The real time results (Figure 2, left image) revealed the twisted-off tubing and provided key information about the size, position, and condition of the tubing top. The client was able to see immediately that the tubing top lay towards the high side of the well. It also showed that the tubing top was thoroughly mangled, and crucially, that a section of the tubing had folded over.
