# First-ever VR90s\* operation completed

Clear answers from VR90s Advanced Diagnostic Service enables client to proceed with intervention plan.

CASE STUDY

Client: Major Dutch operator

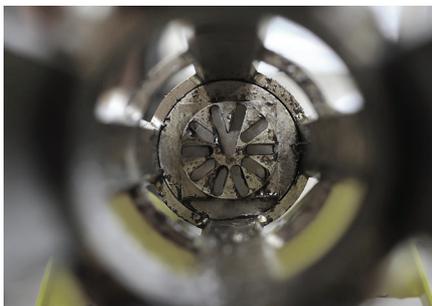
The VR90s tool was run in hole until it tagged an obstruction, which upon imaging, was revealed to be the nipple. The X-ray image acquired (below left) shows the 2.9 in nipple ID, highlighted by the circle annotation. The red and orange region indicates debris on the low side of the well.

The VR90s tool's built-in positioning module was then used to move the VR90s tool 5.5 cm above the nipple. A new X-ray image was acquired (below right), revealing a round profile with a 3.5 in ID. The red and orange region indicate debris on the low side of the well, and the upper portion of the ID appears to be free of fluid, indicating that the ID is not completely filled with debris.

By running the VR90s service, the client was finally able to obtain images despite the conditions within their well, and ascertain the location of the fish. The VR90s diagnosis provided the client with a better foundation for decision-making, subsequently de-risking their future intervention plan.
