VR90® X-ray diagnosis illuminates problem with stuck tubing

Downhole X-ray imaging provides dimensions and location of tubing top to guide fishing.

CASE STUDY

Client: Large independent operator, US land

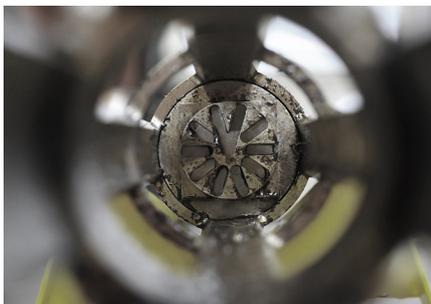
The 3D reconstruction shown in the first image on the right, shows the damaged and uneven condition of the fish. Additionally, on the left side, debris can be seen that was consistent with the size of returns found when pulling out of hole.
