EVALUATIVE CASE STUDY

Trouble Milling a Frac Plug

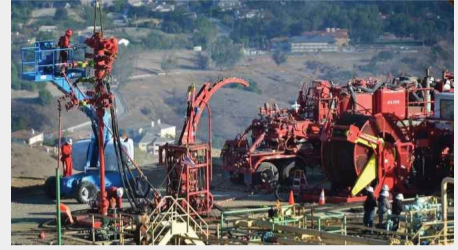
Problems Milling

Long after the point that the plug should have been milled out there is still no debris in the returns and no signs of progress.

A lead impression block is run; results show that something may be on top of the plug.
A junk basket recovers nothing.
An optical camera would require a cleanup.
